What went wrong?

An Investigative Report into the Extended Well Test Undertaken by:

Rathlin Energy (UK) Limited
at
West Newton A Wellsite
Fosham Road
Marton
HU11 5DA

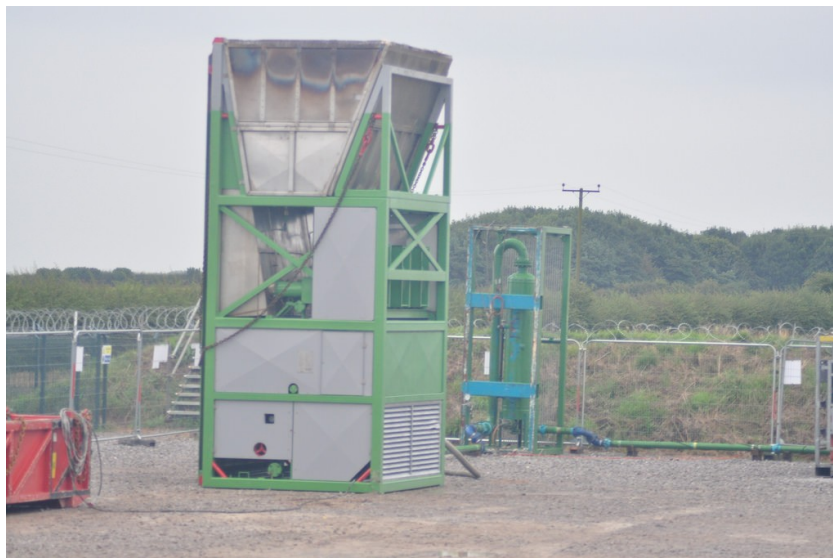
Enclosed Single Flare – West Newton A

Rathlin Energy, after considering alternative methods of flaring, undertook to use a single tip shrouded flare through which to vent waste gas collected as a by-product of testing at West Newton A well site. An assessment to determine the “likely impact of flaring operations on local air quality, in particular sensitive areas of habitation, and attainment of applicable air quality standards” (Environmental Scientifics Group Limited, 2013, p.3) was produced.

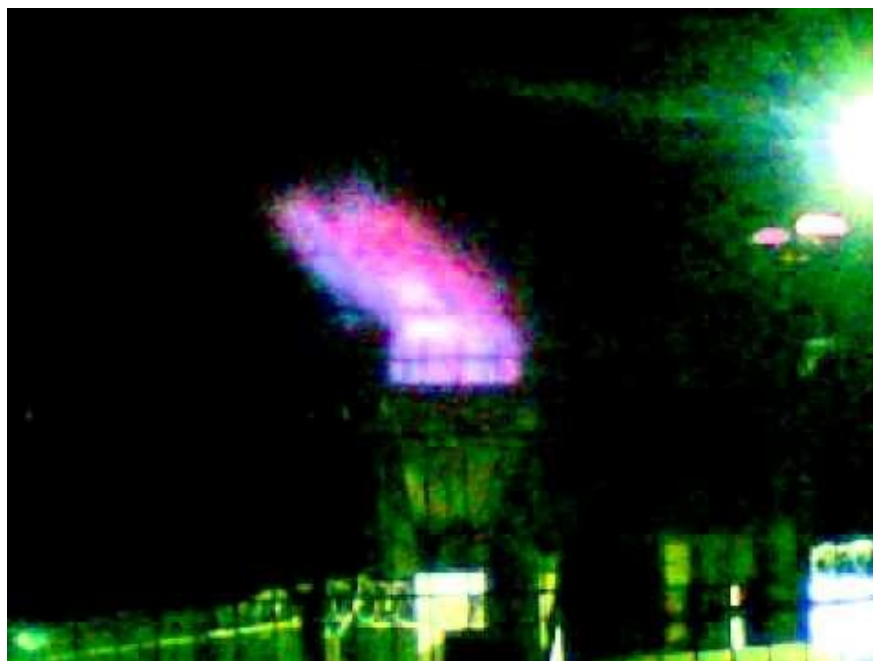
Night Time Flaring – West Newton A

Following the inspection carried out on 22 October 2014 by the Environment Agency three breaches to permit condition 3.3.1 were noted with cold venting having taken place on 05, 15 and 17 October 2014. A further comment was added, “*multiple failures of permit conditions cannot be adequately reported within a single CAR form*”. (*Environment Agency, 2012g*)

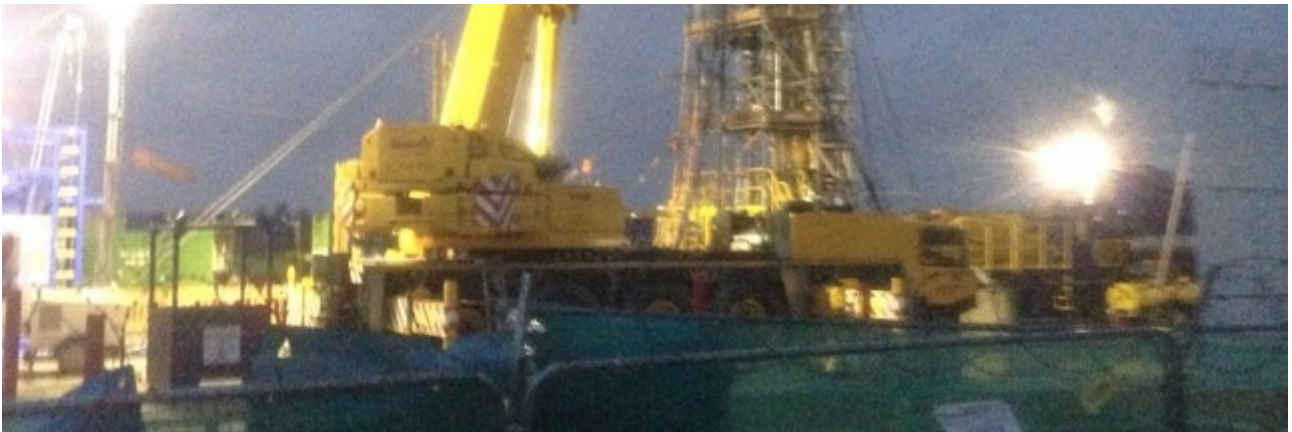
Rig and tower lighting – West Newton A

Throughout the duration of the Extended Well Test the badly angled floodlighting sent a glare into residents’ homes that penetrated curtains and illuminated bedrooms. In 2004 published research demonstrated a link between artificial night time light causing higher rates of breast and colorectal cancers in the developed world. (Pauley, 2004)

Despite the LMP stipulating four lighting towers would be the maximum requirement six towers were eventually on site. The illumination from four towers adversely affected residents in Withernwick and the impact when six towers were in operation was considerably worse.

In spite of numerous complaints from Residents and Activists Rathlin Energy did not discuss any of the issues raised or make plans to mitigate the impact. No audits to confirm compliance with the agreed plans in the Lighting Management Plan can be found to have been undertaken despite this being specified in the Planning Application. Non-conformances were never addressed and no action was undertaken to mitigate the results of the light pollution.

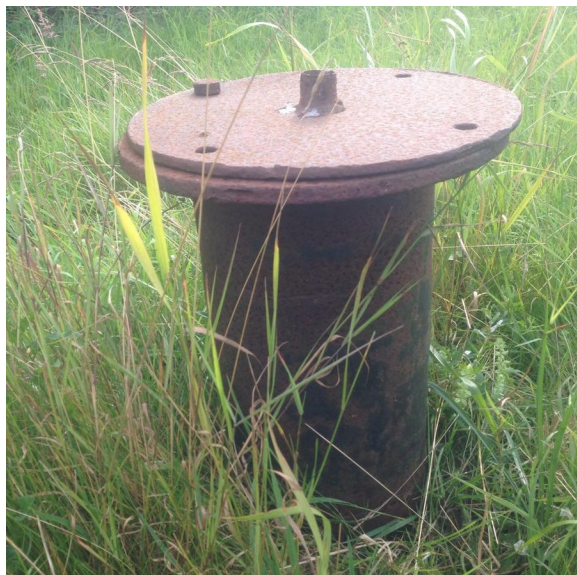
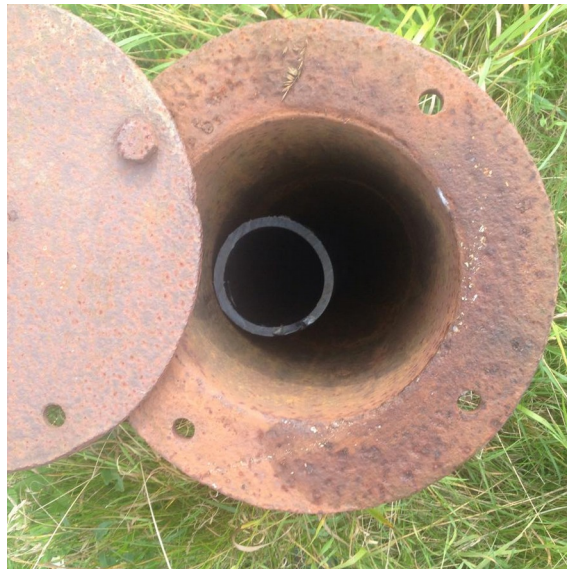
Water monitoring borehole in East Riding of Yorkshire
Constructed in 1971 to a depth of 121 meters

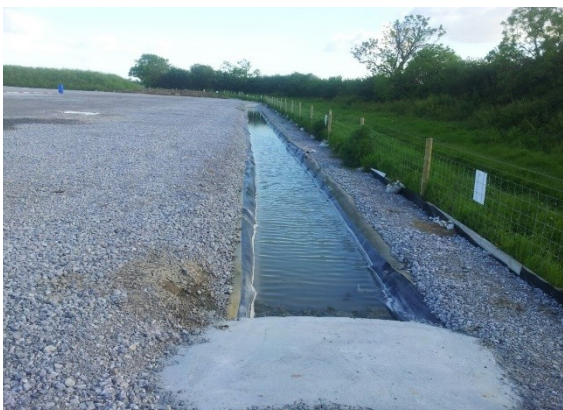
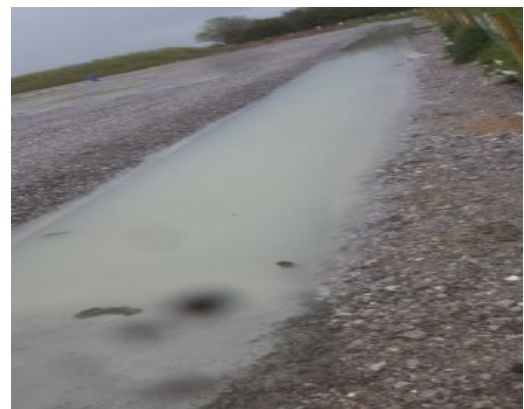
During early May, following several days of rain, the perimeter drainage ditch overflowed to such an extent it was running into the ditch, alongside the compound, that feeds into the Lambwath Stream and its Site of Special Scientific Interest. Several telephone calls from concerned residents and Environmental Activists were made over a three day period to the Environment Agency before action was taken and a site visit undertaken. Following this Total Environmental Technology removed 3 tankers of water from the perimeter drainage ditch. (Appendix 29)

Pictures of perimeter drainage ditch prior to overflowing (May 2014)

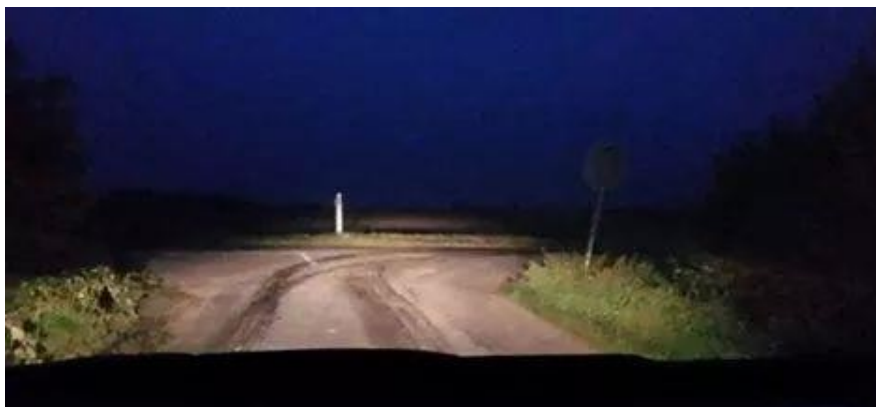
In September 2014 a Total Environmental Technology tanker leaving West Newton A could be seen to be leaking fluid. Leaving a trail stretching from the compound entrance to beyond Marton Junction, with the worst of the leak being seen at Marton Junction adjacent to a pond that feeds into a ditch directly connected to the Lambwath Stream. This was later identified as hydraulic fluid and despite vigorous attempts to notify both the driver and the Police who witnessed the event no action was taken.

Photograph of hydraulic fluid leak (September 2014)

In order to mitigate potential pollution issues from hydraulic fluid leakage a mobile spill cleaning kit should be utilised, this incident is another example of at worst a flagrant disregard of the environmental impact this could have caused and at best a lack of knowledge regarding due process.

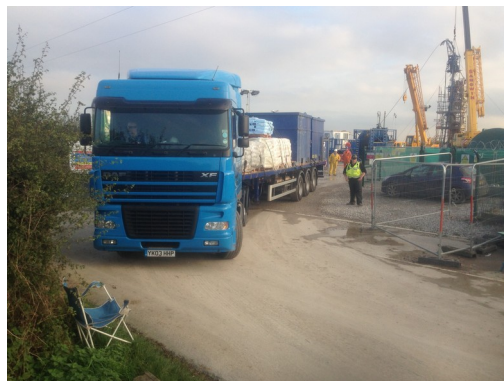
Page 6, point 1 of the Traffic Management Plan (*Rathlin Energy (UK) Limited*) states “All vehicles are to display the Rathlin Energy logo sign, included with this document, in their cab at all times when travelling to and from the site”. It was noted by Activists and Residents monitoring Rathlin Energy and their contractors that from the first vehicle arriving at the site to the last vehicle leaving it during the Extended Well Test not one designated notice was displayed.

Lorry leaving West Newton A

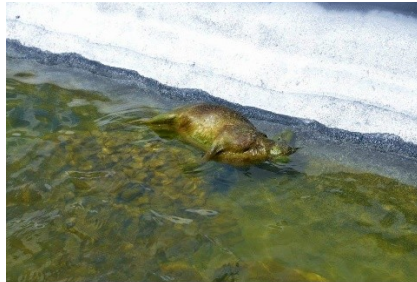
During the second stage well test Residents and Activists reported frequent sightings of brown hares acting uncharacteristically; they were also seen running frantically across the compound in “haphazard” directions. (Appendix 30) Brown hares are timid creatures and there is no doubt the noise from the drilling rig and light from the towers would have disturbed and disorientated them.

Dead brown hare in the perimeter drainage ditch at West Newton A

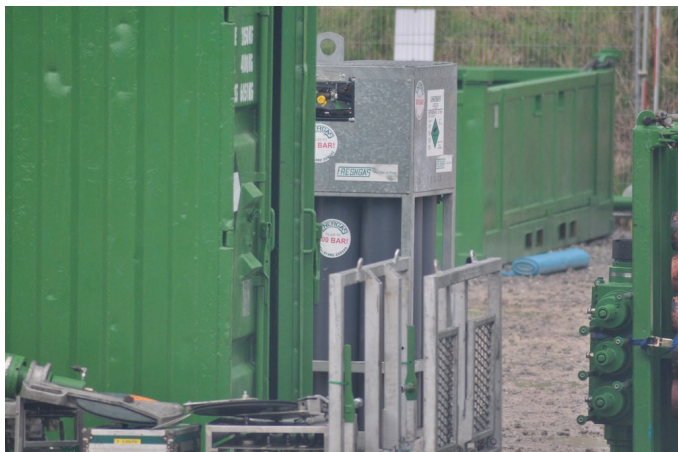
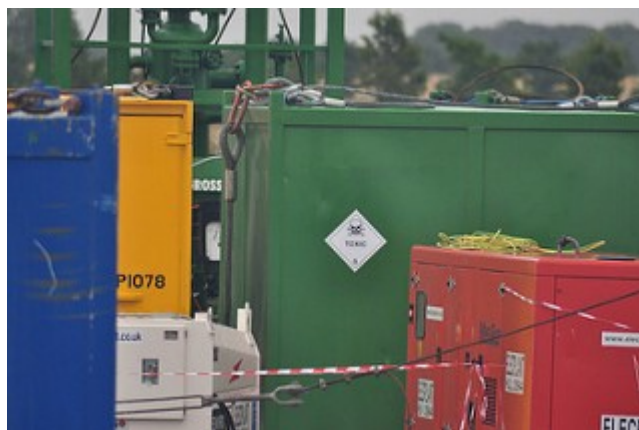
Hazardous Substances – West Newton A

From the above non-conformances it is clear Rathlin Energy were incorrectly managing the Control of Substances Hazardous to Health (COSHH). Had there been an emergency situation on-site staff would have been unable to correctly identify what substances were involved, the toxic level of the substances and therefore, how to correctly to deal with the situation.

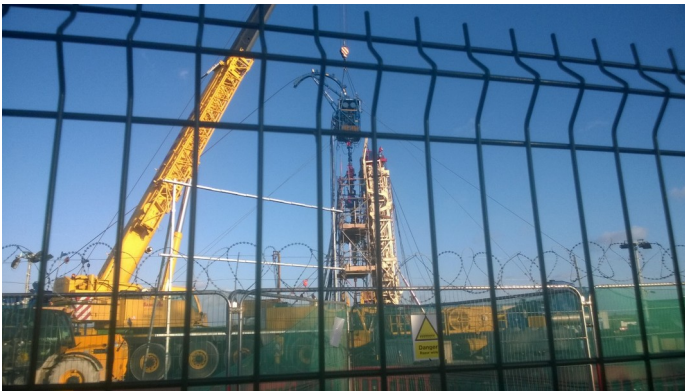
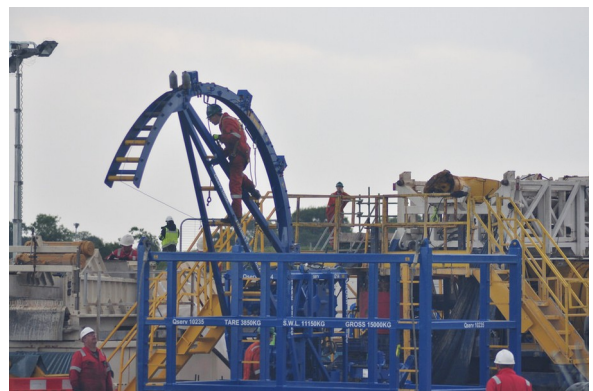
Coiled Tubing at West Newton A

It is said that if used correctly coil tubing can perform almost any operation for oil and gas well operations.
